Contract #: 04-0120F4Cty: SF/Ala Rte: 80 PM: 13.2/13.9File #: 69.28**WELDING INSPECTION REPORT****Resident Engineer:**Siegenthaler, Peter**Address:** 333 Burma Road**City:** Oakland, CA 94607**Report No:** WIR-023742**Date Inspected:** 13-May-2011**Project Name:** SAS Superstructure**OSM Arrival Time:** 1900**Prime Contractor:** American Bridge/Fluor Enterprises, a JV**OSM Departure Time:** 700**Contractor:** Zhenhua Port Machinery Company, Ltd (ZPMC), Changxing Island **Location:** Shanghai, China**CWI Name:** See below**CWI Present:** Yes No**Inspected CWI report:** Yes No N/A**Rod Oven in Use:** Yes No N/A**Electrode to specification:** Yes No N/A**Weld Procedures Followed:** Yes No N/A**Qualified Welders:** Yes No N/A**Verified Joint Fit-up:** Yes No N/A**Approved Drawings:** Yes No N/A**Approved WPS:** Yes No N/A**Delayed / Cancelled:** Yes No N/A**Bridge No:** 34-0006**Component:** OBG Components**Summary of Items Observed:**

OBG Trial Assembly Area

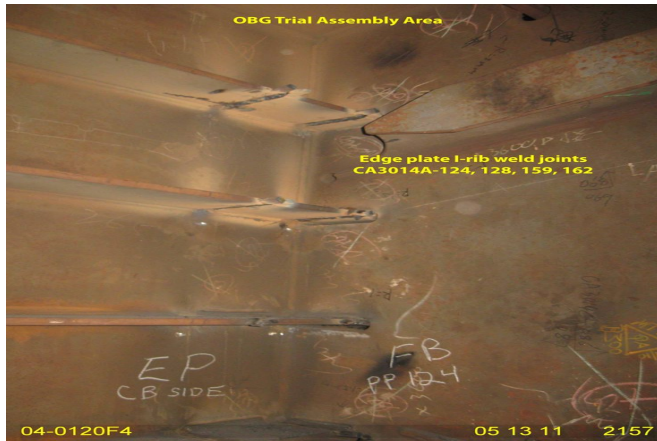
SMAW welding of weld joints CA3014A-124, 128, 159, 162 located on PCMK OBG 13CW. Welder was identified as 058102. QC was identified as ZPMC CWI Sha Zhi (QC1). Assisting QC1 at this location and appearing to be monitoring the welding operation and recording data was ZPMC QC Xie Ming Feng (QCA1), who was not a CWI. Weld variables recorded by QCA1 appeared to comply with WPS-B-P-2214-B-U2-FCM-1 as verbally identified by QCA1. See photo below of the weld joints after welding.
